DATE: September 6, 2019
TO: PROSPECTIVE CONSULTANTS
SUBJECT: **RFP FOR PARKS AND RECREATION MASTER PLAN UPDATE (PROJECT NO. 5115) - QUESTIONS AND CLARIFICATIONS No. 1**

FACILITY CONDITION ASSESSMENT

City of Milpitas
1265 North Milpitas Boulevard
Milpitas, California 95035
Tony Ndah

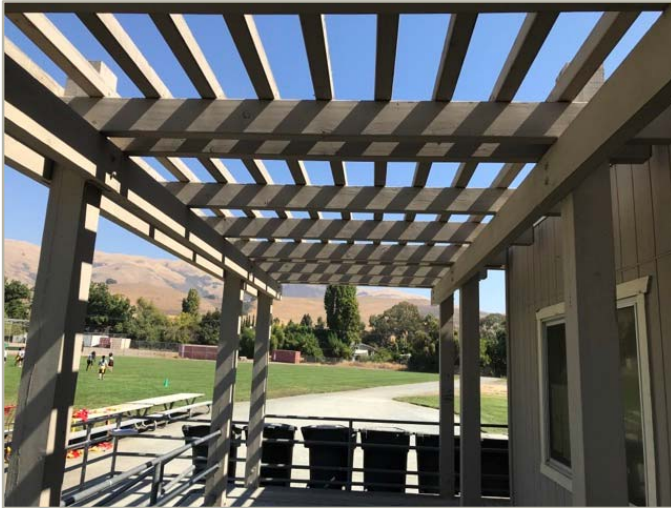
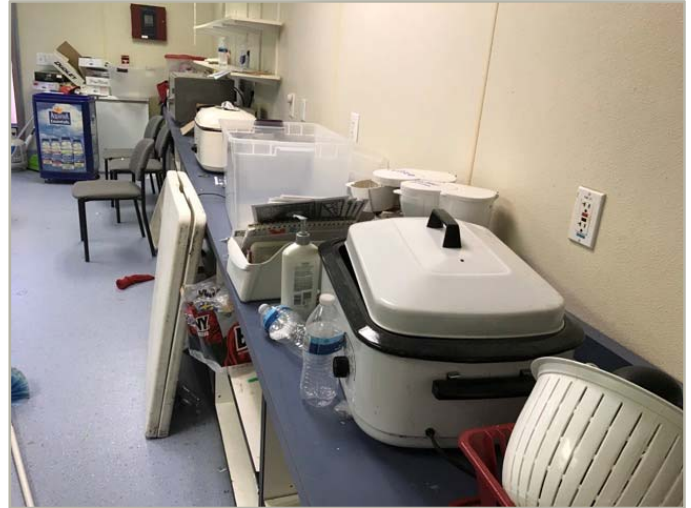
3 Russell Middle School Summary

HVAC	No cooling, electric wall heaters	Fair
Fire Suppression	Wet-pipe sprinkler system; fire extinguishers	Fair
Electrical	Source & Distribution: Main panel with copper wiring Interior Lighting: T-8, Emergency: None	Fair
Fire Alarm	Alarm panel, smoke detectors, alarms, strobes, pull stations	Fair
Equipment/Special	Commercial kitchen equipment	Fair
Site Pavement	Not reviewed	--
Site Development	Not Reviewed	--
Key Issues & Findings	Exterior hardboard siding is rotting, replacement recommended.

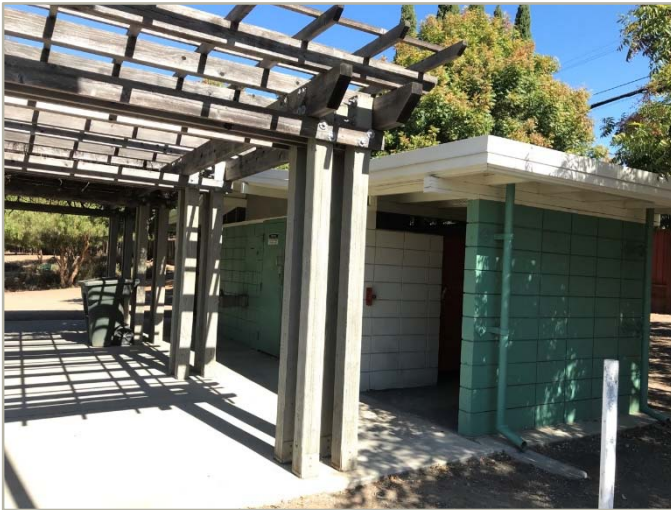
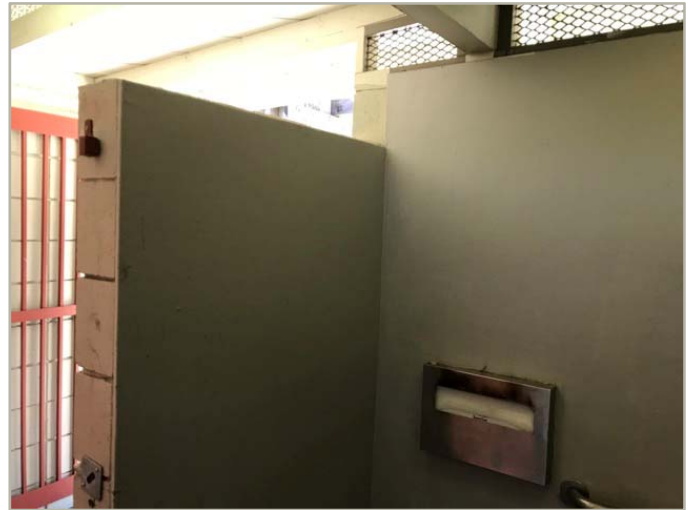
5 Augustine Memorial Park Summary

HVAC	None	--
Fire Suppression	Fire extinguishers	Fair
Electrical	Source & Distribution: Main panel with copper wiring Interior Lighting: T-12 Emergency: None	Fair
Fire Alarm	None	--
Equipment/Special	None	--
Site Pavement	Not reviewed	--
Site Development	Not reviewed	--
Key Issues & Findings	Aged distribution panels, Failed drinking fountain and floor drain, ADA items

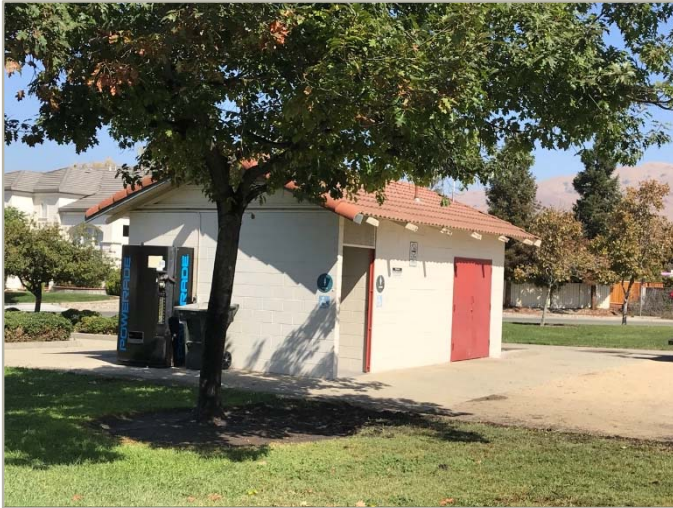
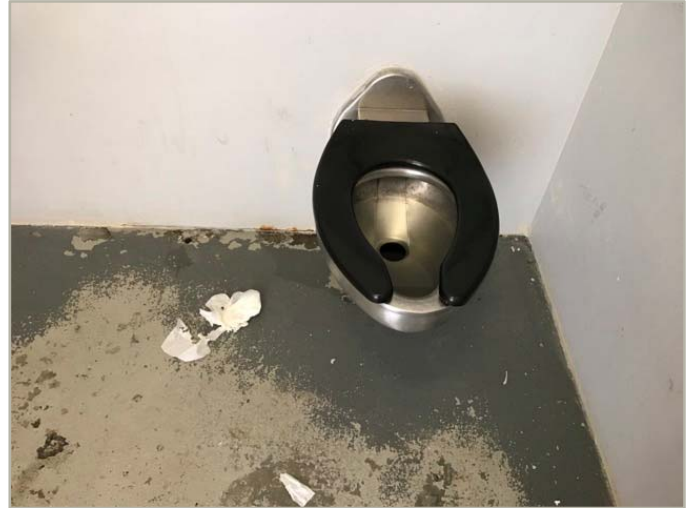
6 Gill Memorial Park Restroom Summary

HVAC	None	--
Fire Suppression	Fire extinguisher	Fair
Electrical	Source & Distribution: Main panel with copper wiring Interior Lighting: T-12 Emergency: None	Fair
Fire Alarm	None	--
Equipment/Special	None	--
Site Pavement	Not reviewed	--
Site Development	Not reviewed	--
Key Issues & Findings	The rafter tails have dry rot, the electric panel is aged, several receptacles should be waterproof & GFCI, ADA items

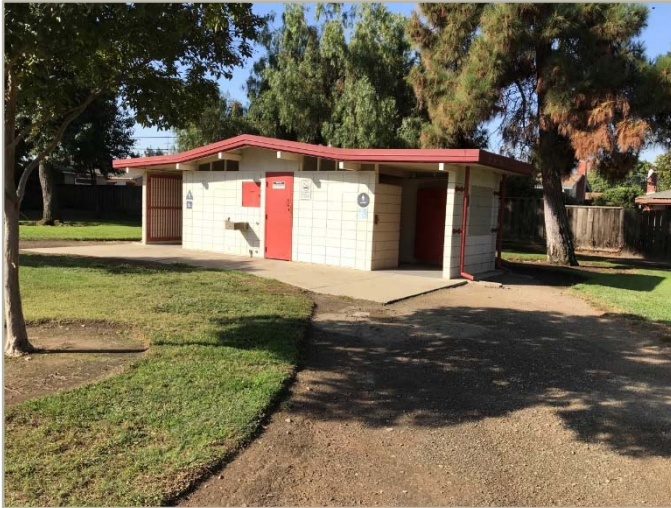
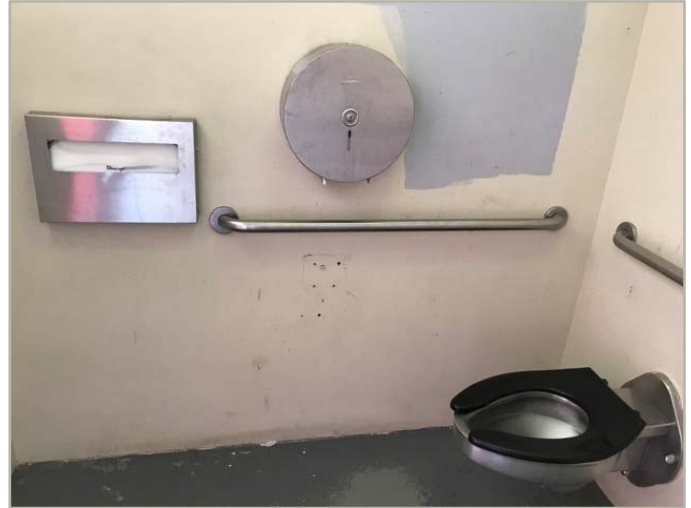
8 Starlight Park Summary

Starlight Park Information		
Elevators	None	--
Plumbing	Copper supply and cast iron waste & venting	Fair
HVAC	None	--
Fire Suppression	Fire extinguisher	Fair
Electrical	Source & Distribution: Main panel with copper wiring Interior Lighting: CFL Emergency: None	Fair
Fire Alarm	None	--
Equipment/Special	None	--
Site Pavement	Not reviewed	--
Site Development	Not reviewed	--
Key Issues & Findings	Termite damage

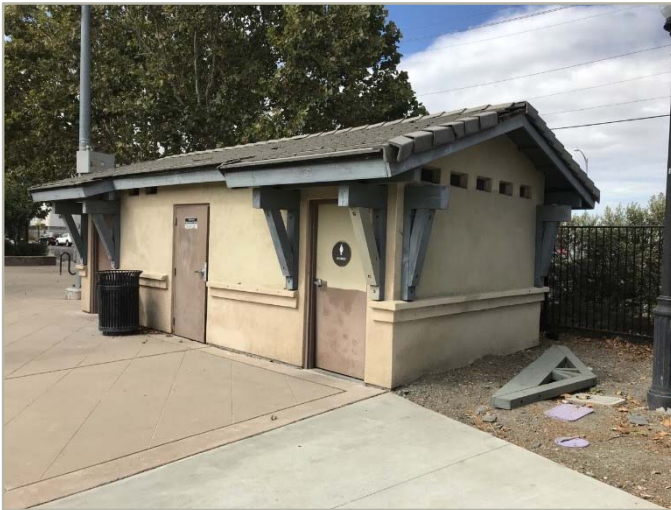
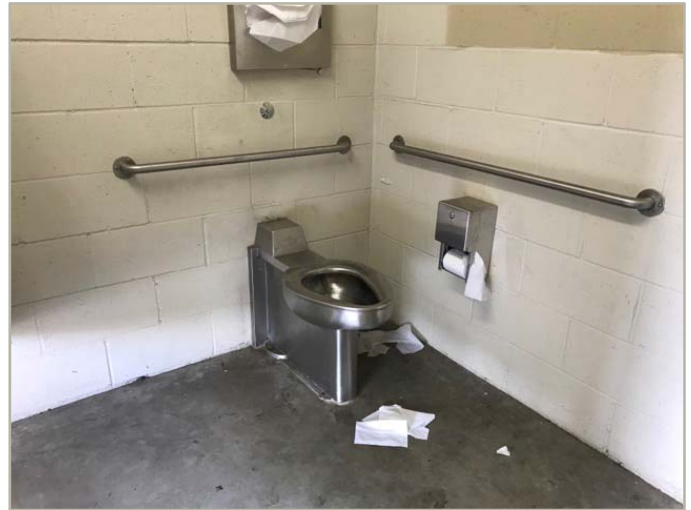
11 Parc Metro East Summary

Parc Metro East Information		
Plumbing	Copper supply and cast iron waste & venting No hot water	Fair
HVAC	Natural air ventilation	Fair
Fire Suppression	Fire extinguisher	Fair
Electrical	Source & Distribution: Main panel with copper wiring Interior Lighting: T-8, incandescent Emergency: None	Fair
Fire Alarm	None	--
Equipment/Special	None	--
Site Pavement	Not reviewed	--
Site Development	Not reviewed	--
Key Issues & Findings	Minor stucco damage near trash cans, large decorative truss has fallen from the right side, the maintenance door is damaged and difficult to open, many roof tiles are damaged, fire extinguisher needs to be mounted, LED lighting upgrade recommended, missing mirror above sink, wrapping sink drains for ADA is recommended.

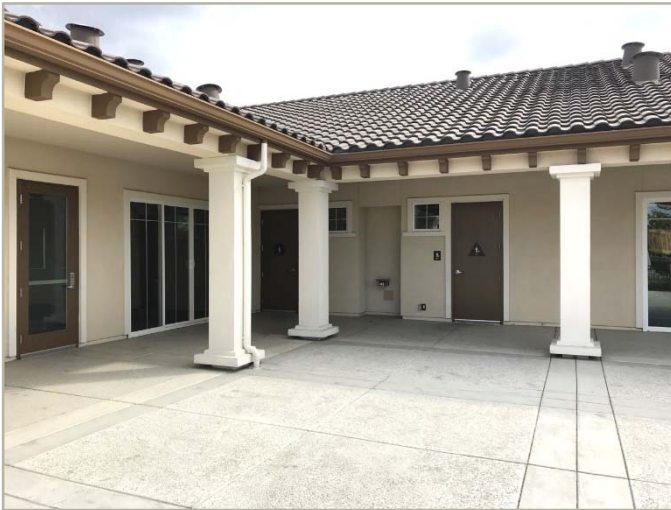
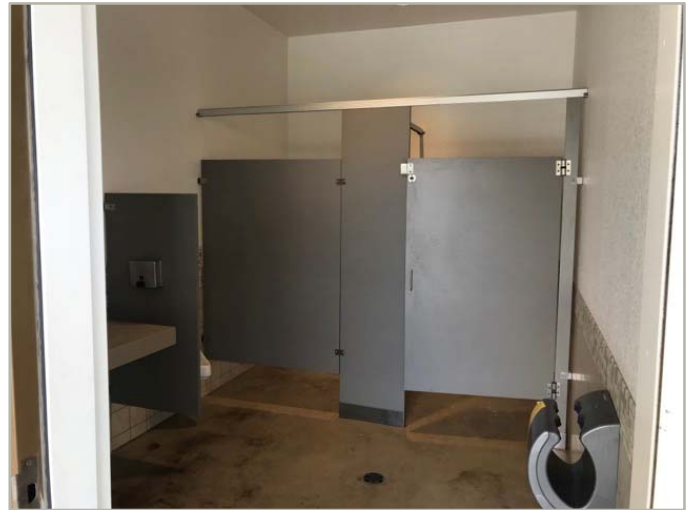
12 Bob McGuire Park Summary

Address	791 Garden St, Milpitas, CA	
Constructed	2016	
Building Size	240 SF	
Number of Stories	One	
<i>System</i>	<i>Description</i>	<i>Condition</i>
Structure	Conventional wood frame structure on concrete slab and wood-framed roofs	Good
Façade	Stucco with vinyl windows	Good
Roof	Gable construction with clay/concrete tiles	Good
Interiors	Walls: Painted gypsum board with ceramic tile wainscoting Floors: Stained concrete Ceilings: Painted gypsum board	Good
Elevators	None	--

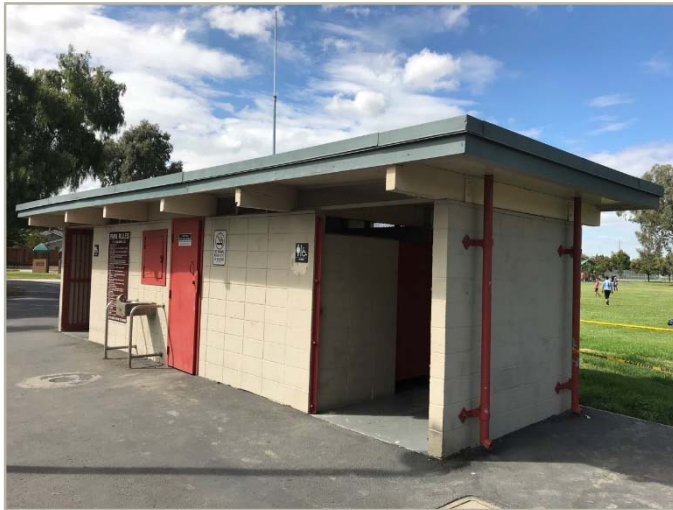
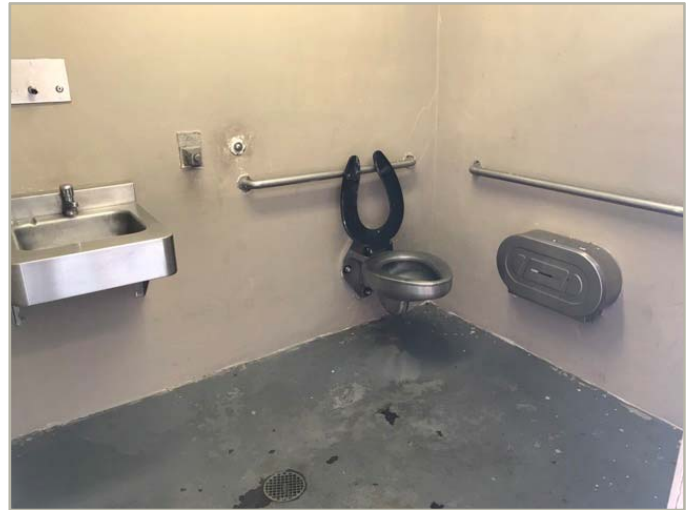
13 Pinewood Park Summary

Address	Starlight Drive and Lonetree Court, Milpitas, California	
Constructed	1960s	
Building Size	280 SF	
Number of Stories	One	
<i>System</i>	<i>Description</i>	<i>Condition</i>
Structure	Masonry bearing walls on concrete slab	Good
Façade	Painted CMU with no windows	Fair
Roof	Flat construction with modified bituminous finish	Fair
Interiors	Walls: Painted CMU with skim coat Floors: Epoxy paint Ceilings: Exposed, painted	Fair
Elevators	None	--
Plumbing	Copper supply and cast iron waste & venting No hot water	Fair

HVAC	None	Fair
Fire Suppression	Fire extinguisher	Missing
Electrical	Source & Distribution: Main panel with copper wiring Interior Lighting: T-12, incandescent Emergency: None	Poor
Fire Alarm	None	--
Equipment/Special	None	--
Site Pavement	Not reviewed	--
Site Development	Not reviewed	--
Key Issues & Findings	Dry rot on roof beam tails, antiquated plumbing and electrical infrastructure, missing fire extinguisher, recommend replacement of sink faucets, replacement and relocation of hand driers and soap dispensers, sink drains need to be wrapped for ADA compliance.

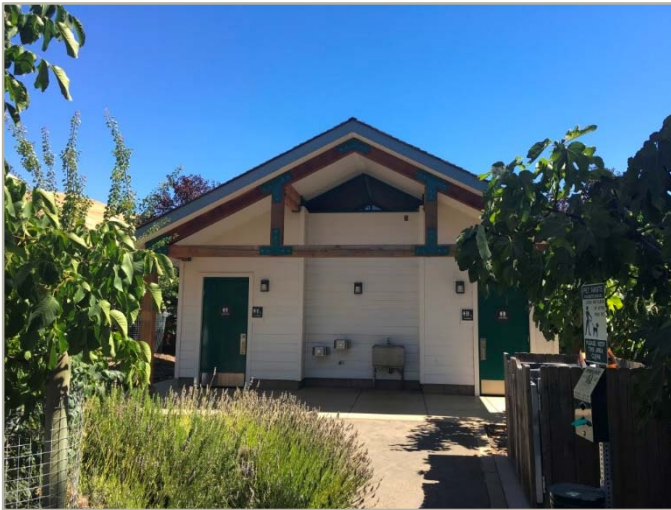
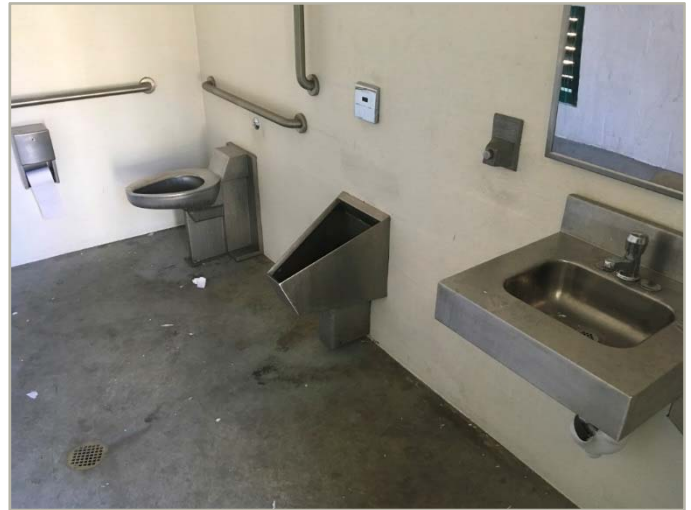
14 Alviso Adobe Park Restroom Summary

Address	2087 Alviso Adobe Court, Milpitas, California 95053	
Constructed/ Renovated	2013	
Building Size	500 SF	
Number of Stories	1	
<i>System</i>	<i>Description</i>	<i>Condition</i>
Structure	Conventional wood frame structure on concrete slab	Good
Façade	Wood siding and no windows	Good
Roof	Primary: Gable construction with wood shingles	Good
Interiors	Walls: Painted Drywall Floors: Unfinished Ceilings: Painted Drywall	Fair

Alviso Adobe Park Restroom Information		
Elevators	None	--
Plumbing	Copper pipe supply and cast iron waste & venting No hot water	Good
HVAC	None	--
Fire Suppression	Fire extinguishers	Failed
Electrical	Source & Distribution: Fed from Water Tower building with copper wiring Interior Lighting: CFL	Good
Fire Alarm	None	--
Equipment/Special	None	--
Key Issues & Findings	Expired fire extinguisher and building lacks fire alarm system

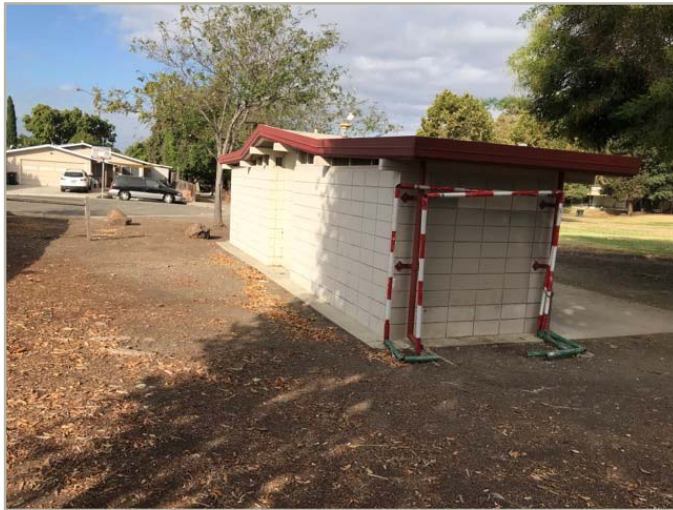
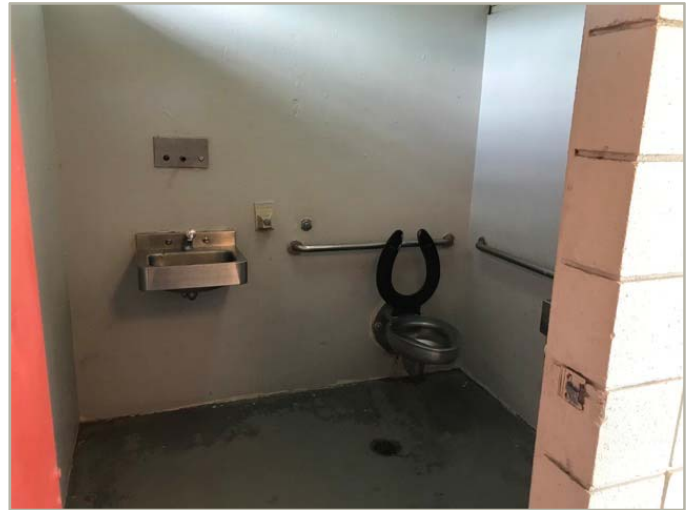
15 Foothill Park Summary

Address	400 Roswell Drive, Milpitas	
Constructed/ Renovated	1960s	
Building Size	280 SF	
Number of Stories	One	
System	<i>Description</i>	<i>Condition</i>
Structure	Concrete block (CMU) structure on concrete slab with wood-framed roof	Fair
Façade	Painted CMU with no windows	Fair
Roof	Primary: Flat construction with modified bituminous finish	Fair
Interiors	Walls: Painted CMU Floors: Epoxy/Unfinished Ceilings: Painted wood	Fair

Foothill Park Information		
Elevators	None	--
Plumbing	Copper supply and cast iron waste & venting No hot water	Fair
HVAC	None	--
Fire Suppression	Fire extinguishers	Fair
Electrical	Source & Distribution: Main panel with copper wiring Interior Lighting: T-12 Emergency: None	Fair
Fire Alarm	None	--
Equipment/Special	None	--
Site Pavement	Not reviewed	--
Site Development	Not reviewed	--
Key Issues & Findings	Possible termite damage, possible structural damage (vertical crack in concrete block)

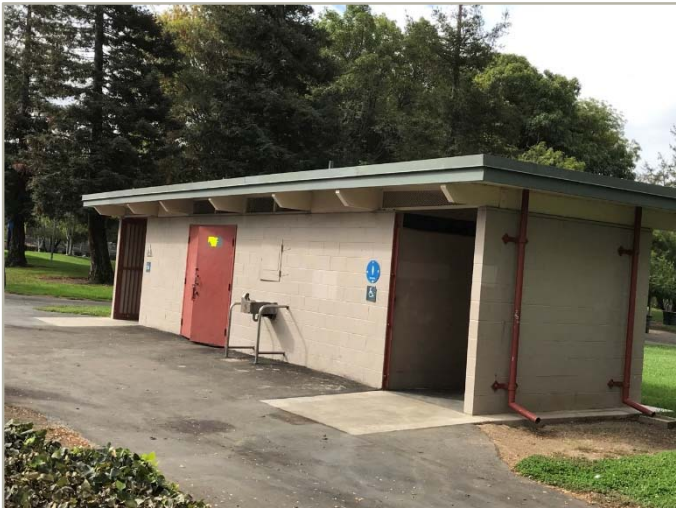
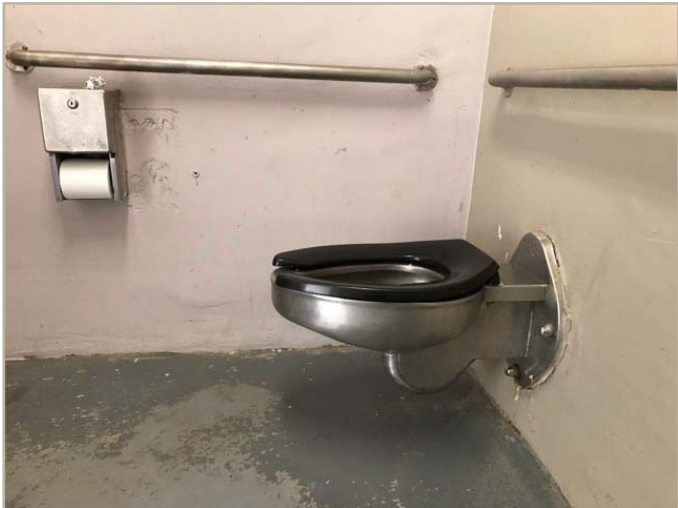
16 Murphy Park Summary

Address	1588 Saratoga Drive, Milpitas, California	
Constructed/ Renovated	1960s	
Building Size	280 SF	
Number of Stories	One	
System	Description	Condition
Structure	Concrete block structure on concrete slab with wood framed roof	Fair
Façade	Painted CMU with no windows	Fair
Roof	Primary: Flat construction with modified bituminous finish	Fair
Interiors	Walls: Painted CMU Floors: Epoxy Ceilings: Painted wood	Fair

Murphy Park Information		
Elevators	None	--
Plumbing	Copper supply and cast iron waste & venting No hot water	Fair
HVAC	None	--
Fire Suppression	Fire extinguisher	Fair
Electrical	Source & Distribution: Main panel with copper wiring Interior Lighting: T-12 Emergency: None	Fair
Fire Alarm	None	--
Equipment/Special	None	--
Site Pavement	Not reviewed	--
Site Development	Not reviewed	--
Key Issues & Findings	Rafter tails show dry rot and possibly termite damage

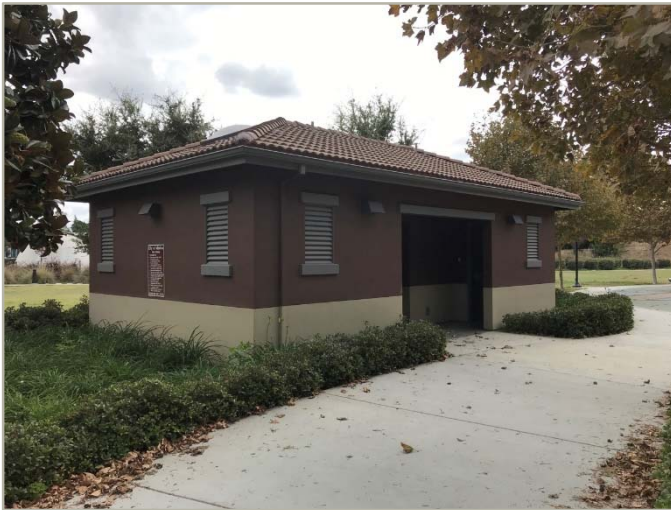
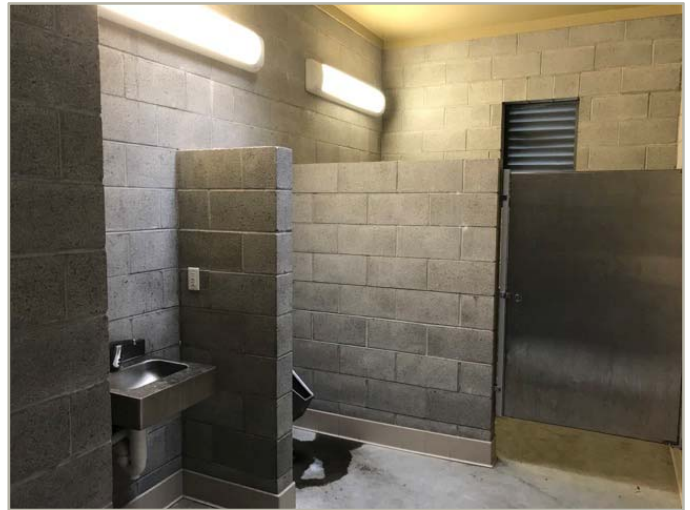
17 Cerano Park Summary

Address	Murphy Ranch Road, Milpitas, California	
Constructed	2012, Estimated	
Building Size	600 SF	
Number of Stories	1	
<i>System</i>	<i>Description</i>	<i>Condition</i>
Structure	Conventional wood frame structure on concrete slab and wood-framed roof	Good
Façade	Stucco with steel vent windows	Good
Roof	Primary: Crossed hip construction with clay/concrete tiles	Good
Interiors	Walls: CMU, Unfinished Floors: Concrete, Unfinished Ceilings: Painted gypsum board	Good
Elevators	None	--

Cerano Park Information		
Plumbing	Copper supply and cast iron waste & venting No hot water	Good
HVAC	None	Good
Fire Suppression	Fire extinguisher	Missing
Electrical	Source & Distribution: Main panel with copper wiring Interior Lighting: LED, motion detectors Emergency: None	Good
Fire Alarm	None	--
Equipment/Special	None	--
Site Pavement	Not reviewed	--
Site Development	Not reviewed	--
Key Issues & Findings	Missing fire extinguisher

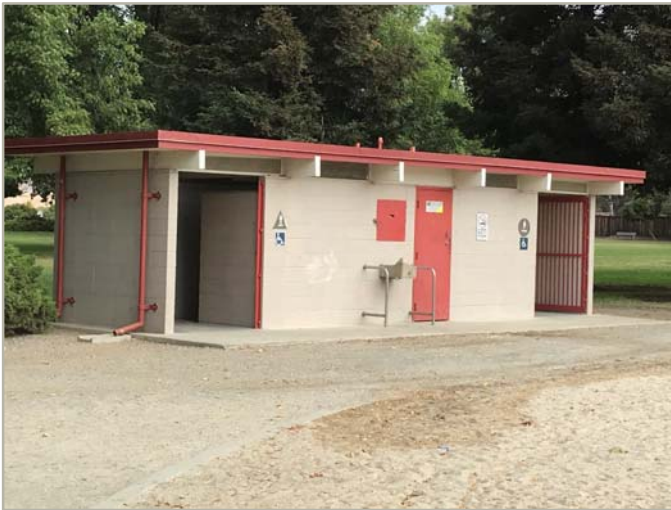
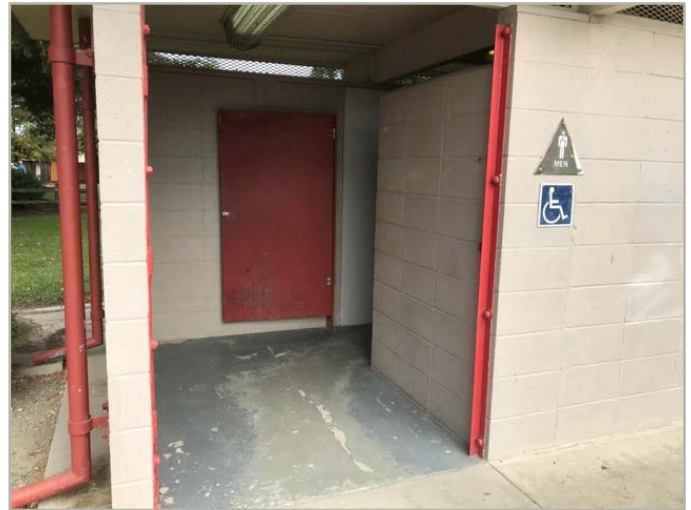
18 Sinnott Park Restrooms Summary

Address	1501 Clearlake Avenue, Milpitas	
Constructed/ Renovated	1960's	
Building Size	280 SF	
Number of Stories	One	
<i>System</i>	<i>Description</i>	<i>Condition</i>
Structure	Conventional wood frame structure on concrete slab and wood-framed roofs	Good
Façade	Painted CMU with no windows	Fair
Roof	Flat construction with modified bituminous finish	Fair
Interiors	Walls: Painted CMU with skim coat Floors: Epoxy paint Ceilings: Exposed, painted	Fair
Elevators	None	--
Plumbing	Copper supply and cast iron waste & venting No hot water	Fair

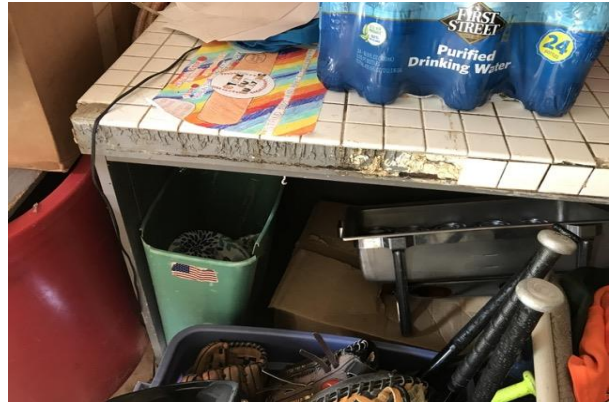
#4

DIXON LANDING KITCHEN
COUNTER

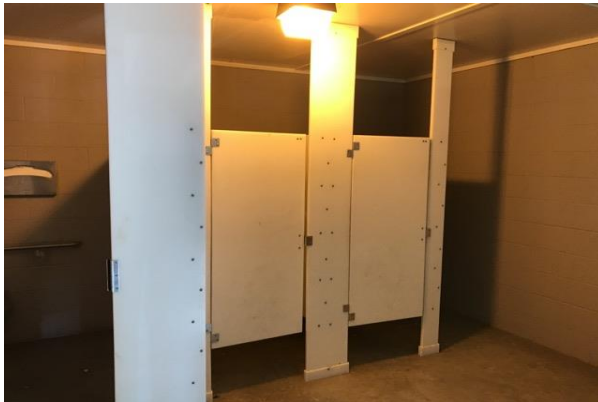
#5

DIXON LANDING TOILET
PARTITIONS,

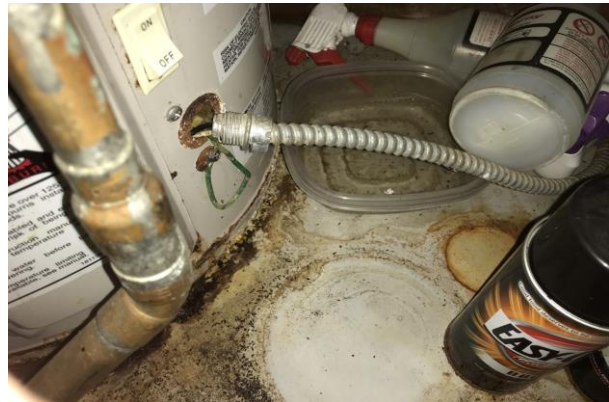
#6

DIXON LANDING WATER
HEATER, ELECTRIC

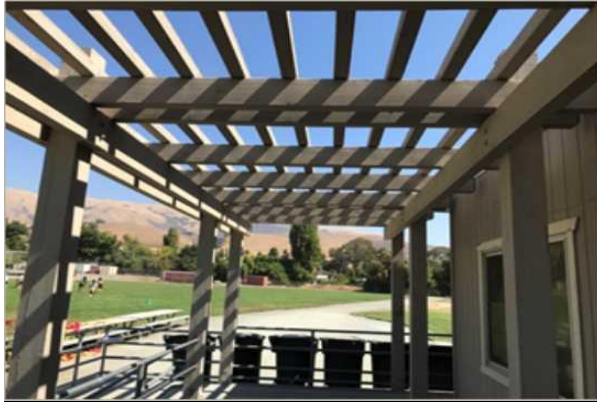
#7

RUSSELL MIDDLE RESTROOM,
EXTERIOR

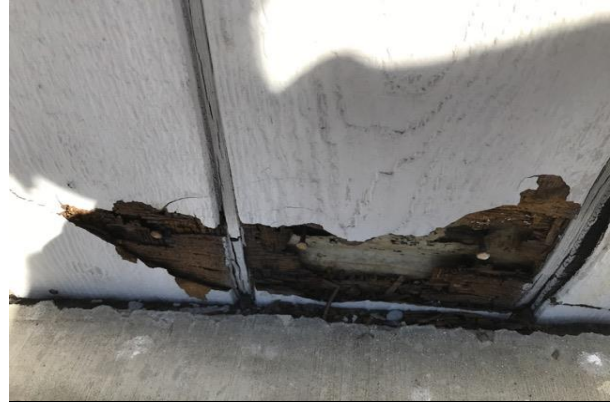
#8

RUSSELL MIDDLE, ROTTING
EXTERIOR SIDING

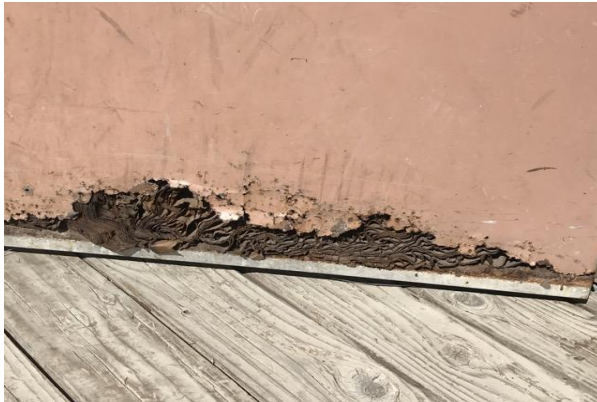
#9

RUSSELL MIDDLE RESTROOM
EXTERIOR STEEL DOOR

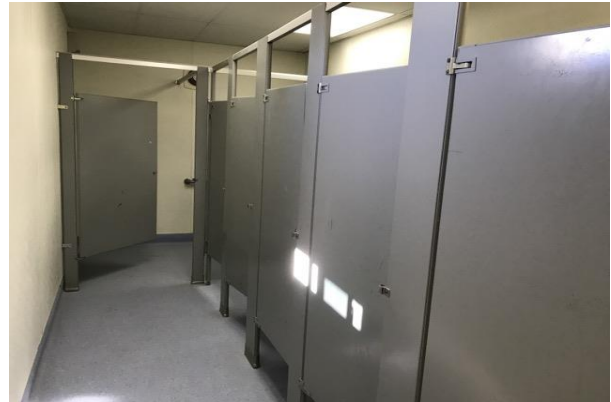
#10

RUSSELL MIDDLE RESTROOM
TOILET PARTITIONS

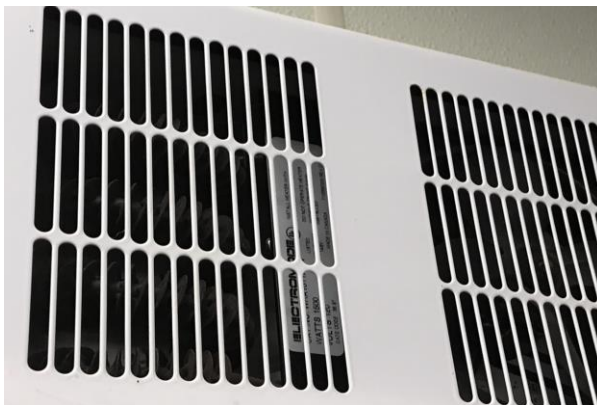
#11

RUSSELL MIDDLE RESTROOM,
HEATER

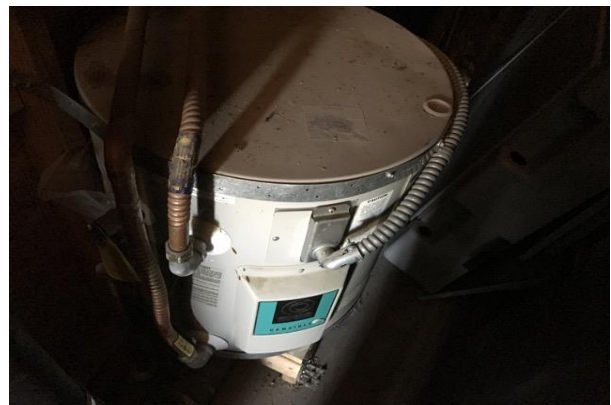
#12

RUSSELL MIDDLE RESTROOM,
WATER HEATER

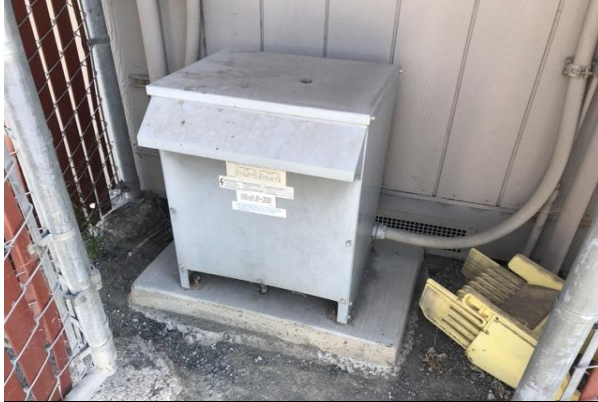
#13

RUSSELL SECONDARY
TRANSFORMER

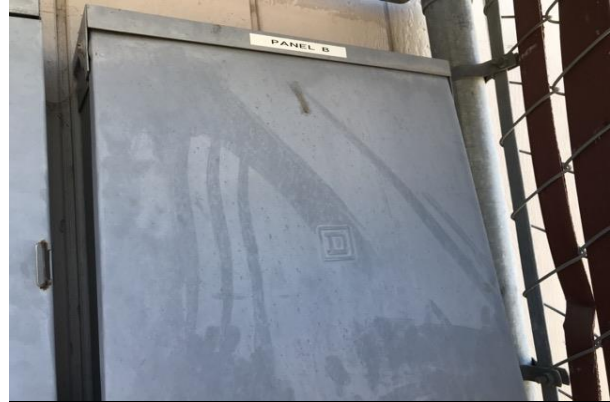
#14

RUSSELL MIDDLE RESTROOM,
DISTRIBUTION PANEL, 208 Y, 120
V, 100 AMP

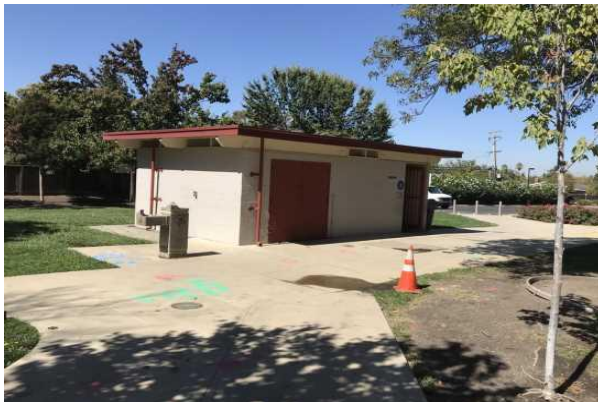
#15

CARDOZA, EXTERIOR

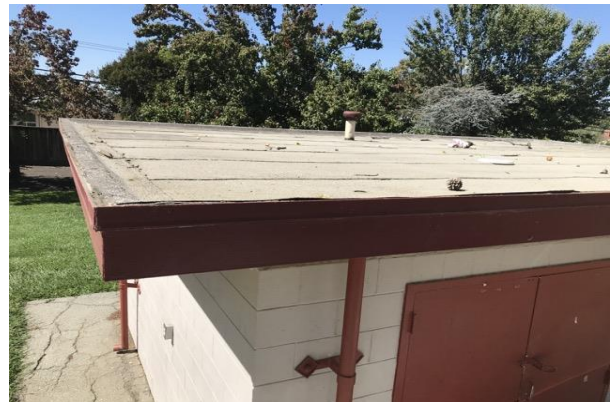
#16

CARDOZA ROOF, MODIFIED
BITUMINOUS

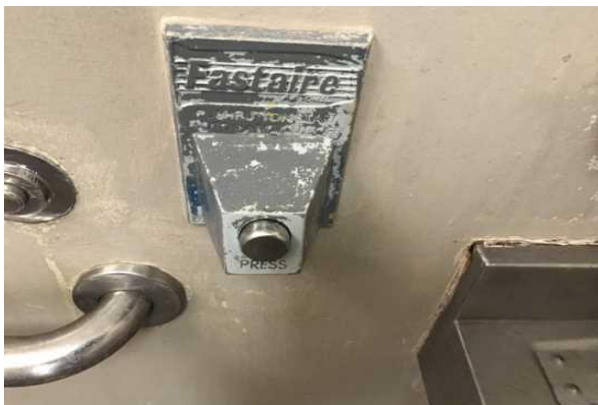
#17

CARDOZA PARK RESTROOMS -
HAND DRYER

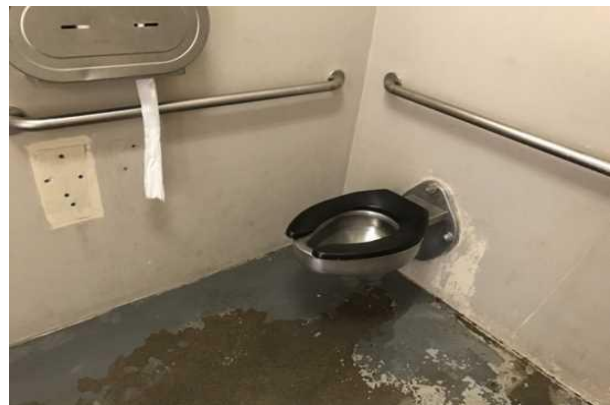
#18

CARDOZA PARK RESTROOMS

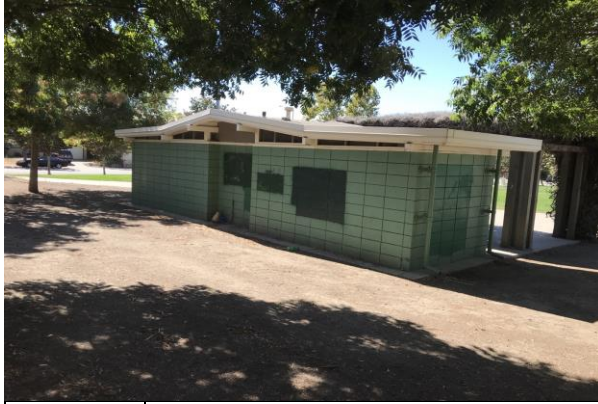
#19 AUGUSTINE REAR ELEVATION

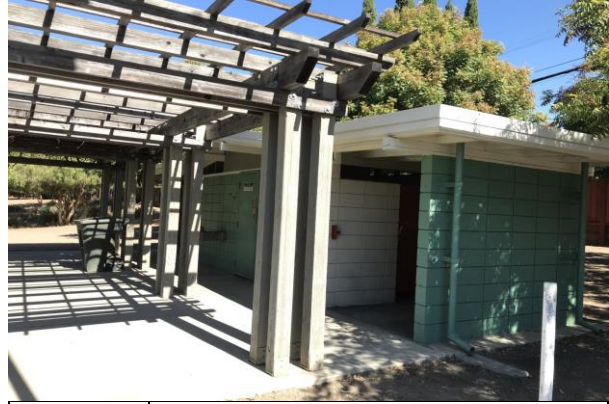
#20 AUGUSTINE PARK RESTROOM

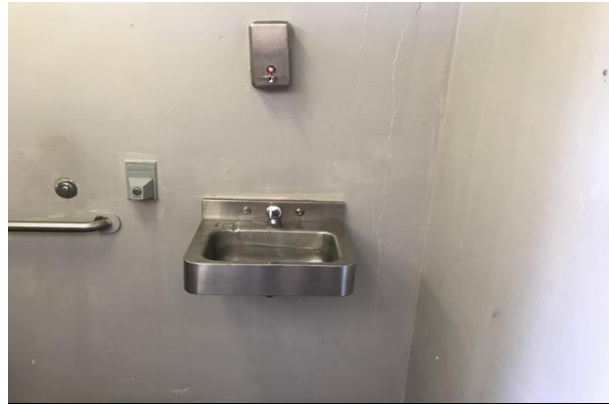
#22 AUGUSTINE, SINK

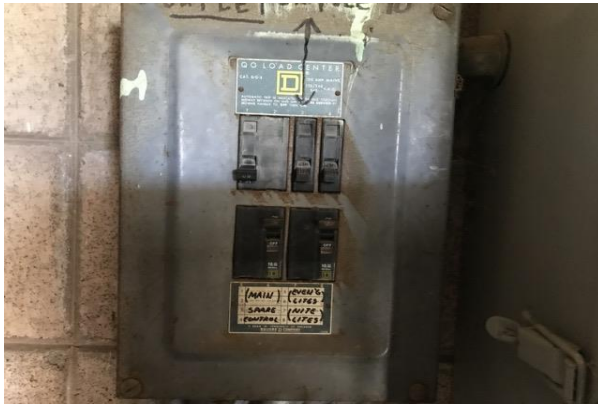
#23 AUGUSTINE DISTRIBUTION
PANEL, 208 Y, 120 V, 100 AMP,

D2033	Augustine	1051707	Floor Drain, , Replace		30	30	0	1	EA	\$406.91	\$498.51	\$499	\$499																						\$499	
D5012	Augustine	1051757	Distribution Panel, 100 AMP, Replace		30	30	0	1	EA	\$5,079.93	\$7,151.07	\$7,151	\$7,151																						\$7,151	
D5012	Augustine	1051721	Distribution Panel, 100 AMP, Replace		30	14	16	1	EA	\$5,079.93	\$7,151.07	\$7,151																	\$7,151						\$7,151	
D5022	Augustine	1051691	Light Dimming Panel, Digital Multi-Purpose Time Control Clock & Photosensor, Replace		15	11	4	1	EA	\$1,596.61	\$2,247.56	\$2,248				\$2,248																	\$2,248		\$4,495

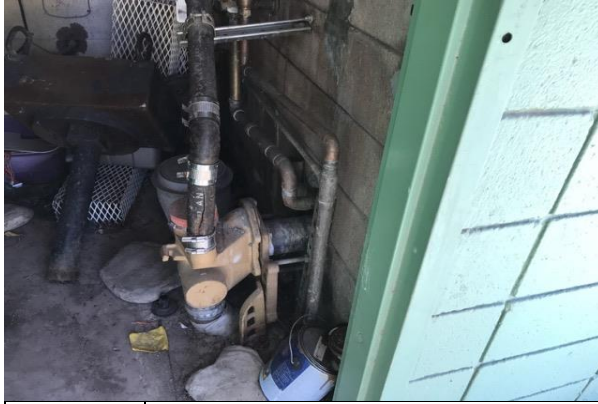
#25

AUGUSTINE PLUMBING

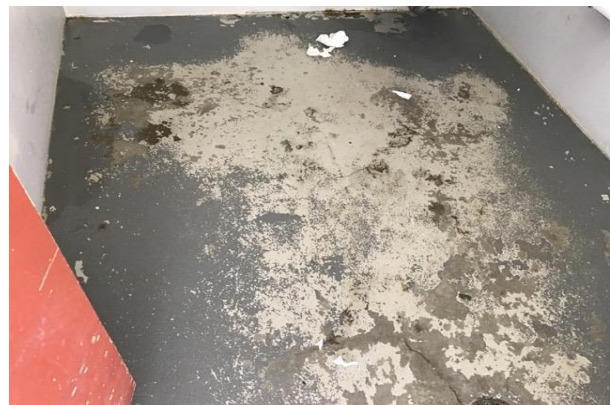
#29

GILL, DAMAGED RAFTER TAILS

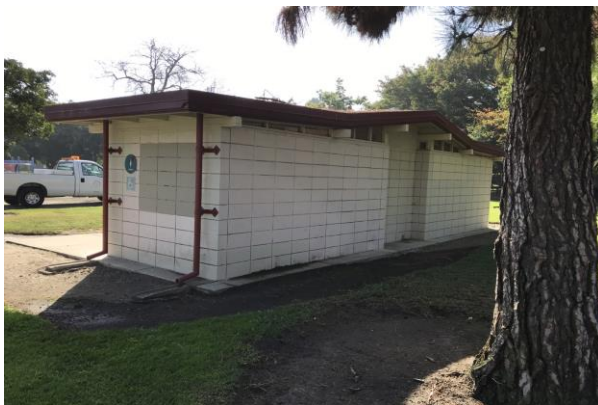
#40

STARLIGHT, TERMITE/ROT
DAMAGE

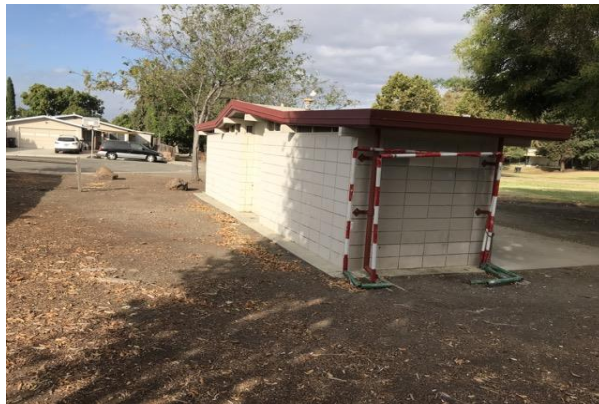
#62

PINEWOOD EPOXY FLOOR
COATING DEGRADATION

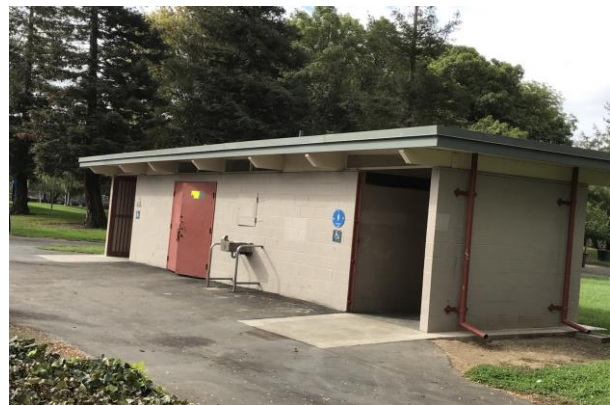
#65

FOOTHILL PARK, STRUCTURAL
CRACK

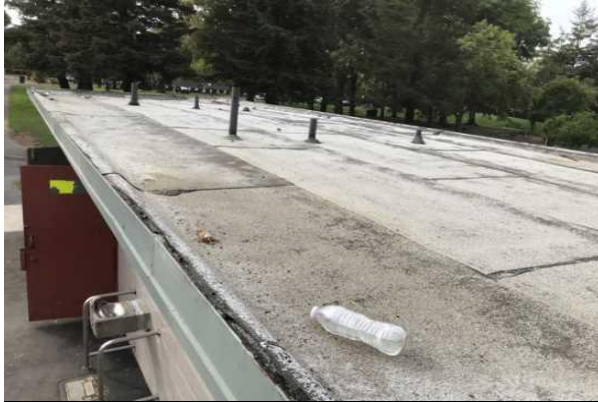
#66

MURPHY PARK RESTROOM

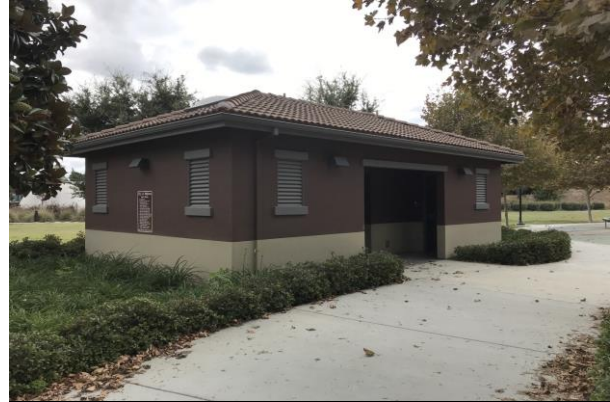
#67

MURPHY PARK ROOF

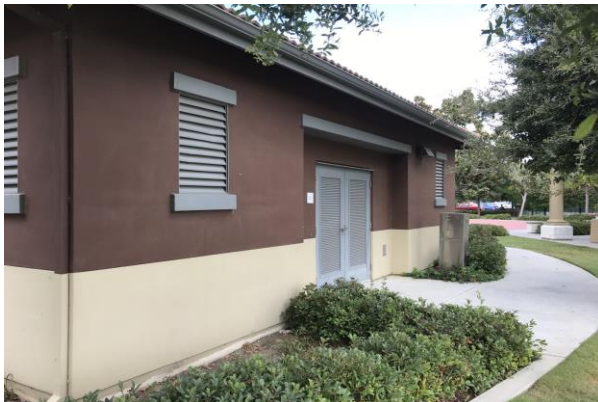
#68

CERANO PARK RESTROOM
